# CHAMBERLAYNE AVENUE WALK ASSESSMENT

Brookland Park Boulevard  
to Mitchell Street Corridor  
Assessment Date: August  
11, 2023

# Pedestrian Safety Assessment

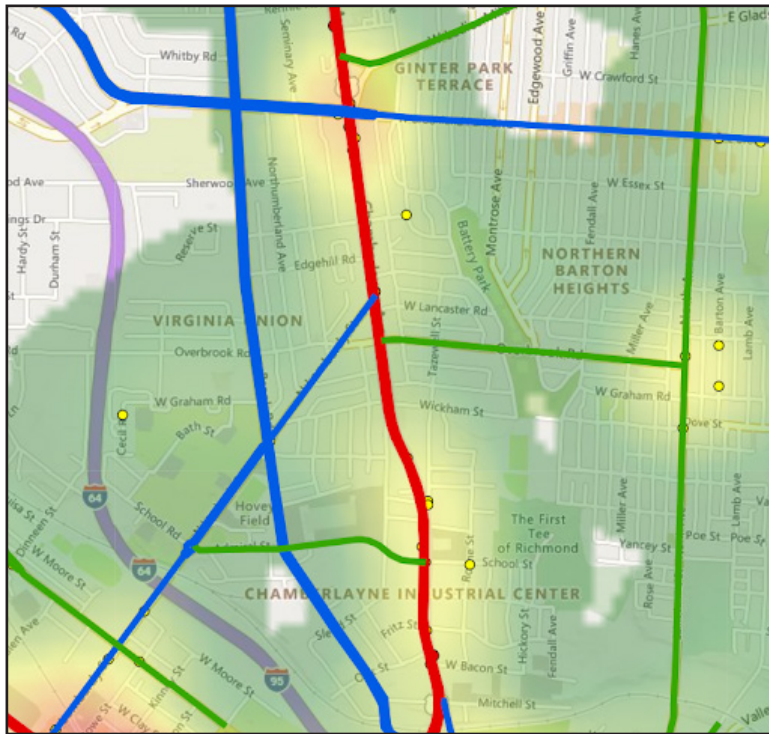
Further underscoring its dangerous reputation, the [Pedestrian Safety Action Plan by VDOT](#) has spotlighted a specific segment of Chamberlayne Ave, stretching from Mitchell Street to Brookland Park Boulevard. This stretch stands out in Virginia's records, earning a grim distinction of being among the state's top 0.1% priority corridors in terms of imminent danger to pedestrians.

**Pedestrian Safety Action Plan**  
 Red line = Top 0.1% statewide pedestrian priority corridors  
 Blue line = Top 1% statewide pedestrian priority corridors  
 Green line = Top 5% statewide pedestrian priority corridors  
 Colored dots = crashes  
 Green shaded area = different densities

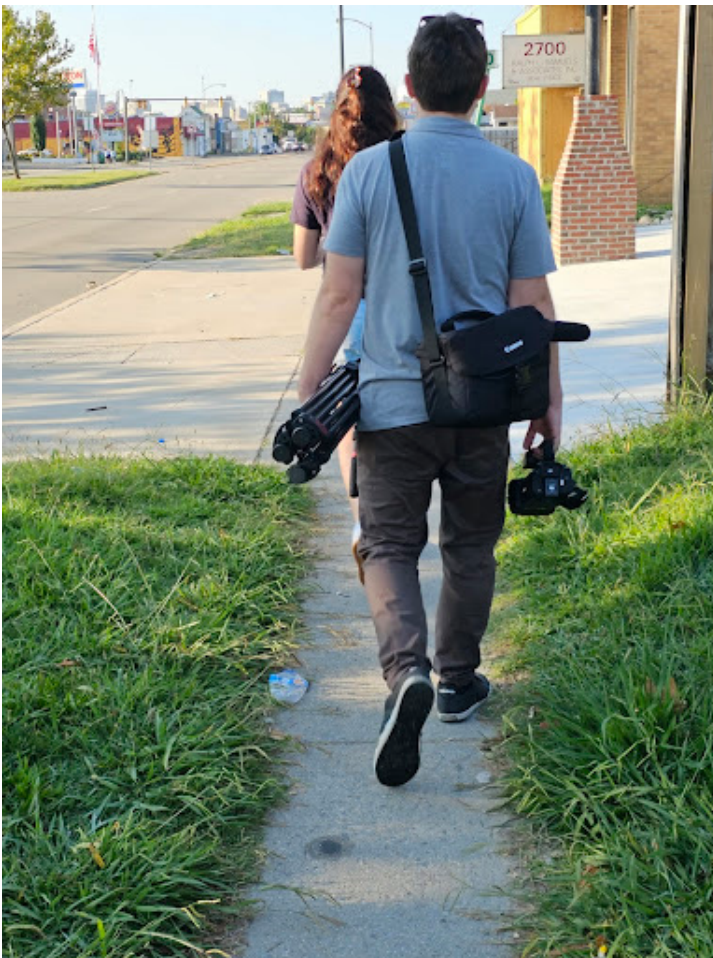
All areas along this corridor are obstructed by overgrowth, debris, and trash

Overgrown grassy areas

Broken glass and other debris hidden in grassy areas are a safety hazard.

Debris creates trip/fall hazard

- Complete installing ADA ramps at every intersection so that people of all abilities can safely cross Chamberlayne Ave.
- Prioritize connectivity of sidewalks and infill sidewalks when missing.
- Set up a maintenance audit and review of broken and overgrown sidewalks and plan/time-frame for fixing them.
- Provide better enforcement for keeping private property (e.g. cars) from blocking the public right of way on sidewalks throughout the corridor.

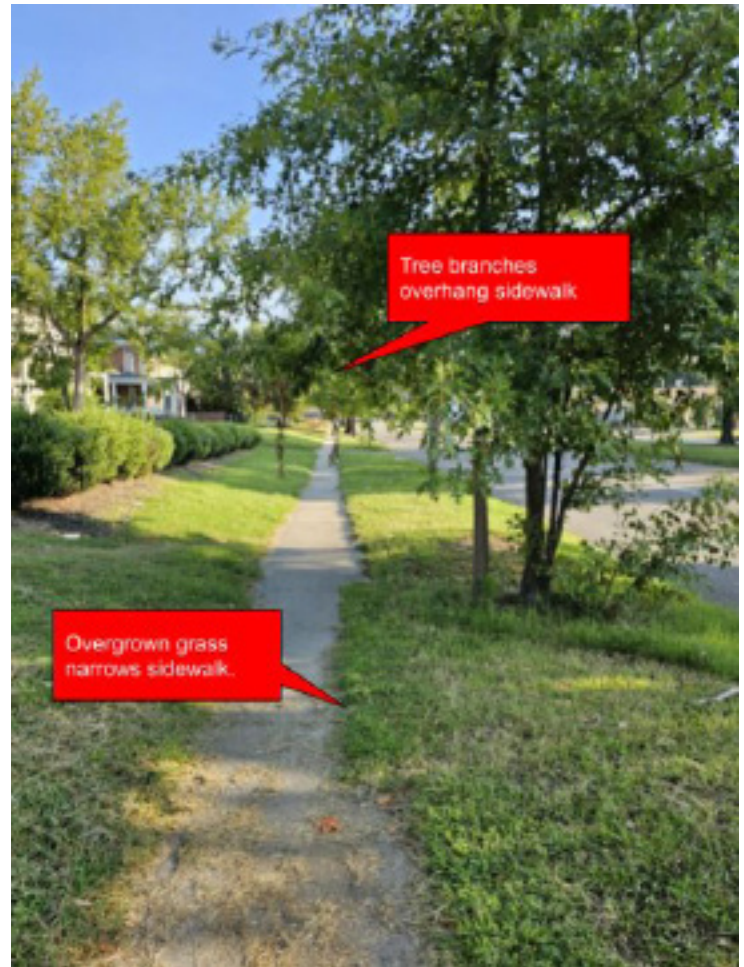
All areas along this corridor are obstructed by overgrowth, debris, and trash

- Overgrown grassy areas
- Broken glass and other debris hidden in grassy areas are a safety hazard.
- Debris creates trip/fall hazard
- Overhanging trees
- Overhanging tree branches impede access to sidewalks
- Limited access to convenient trash receptacles
- Excess litter obstructs sidewalks and grassy areas
- Increases fall/trip hazards

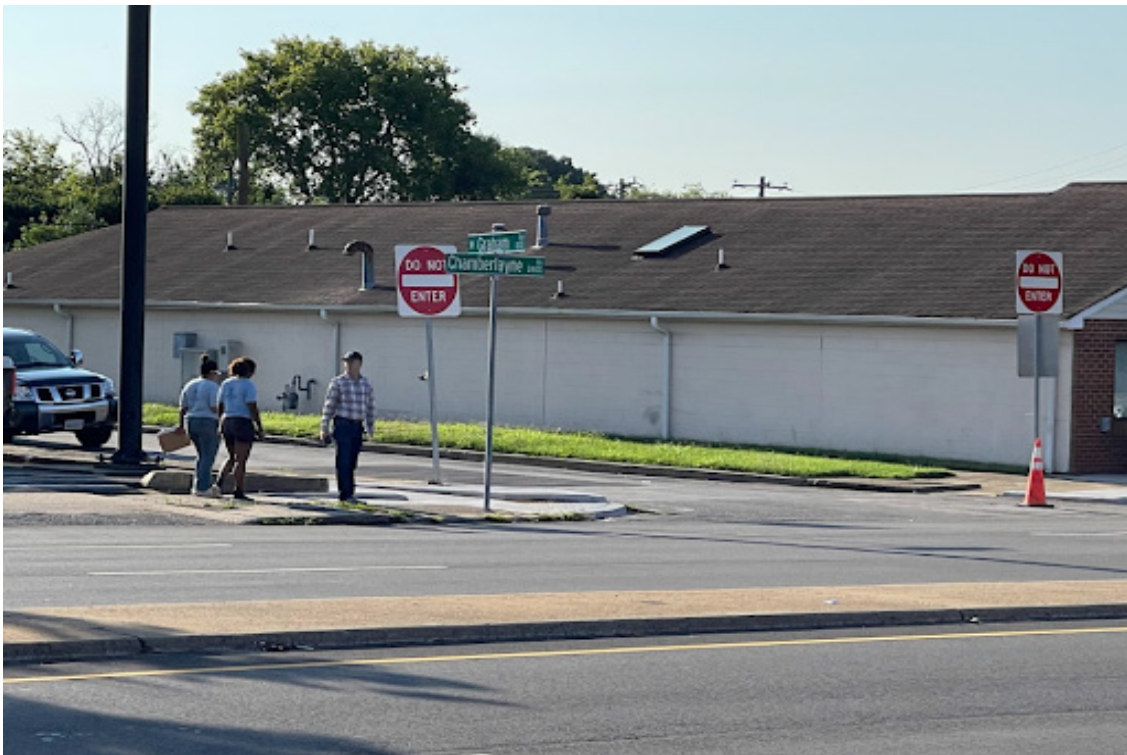
Pedestrians were forced to run and speed walk across six (6) lanes of traffic to reach the “safety” of the other side of the street. Of the fifteen (15) intersections in the study area, just four (4) intersections (Brookland Park Blvd, Lombardy St, Overbrook Rd, School St) have pedestrian signals.

The significant distance between traffic signals along the corridor makes them inconvenient for persons walking and cycling in the area. For example, a pedestrian leaving the Richmond Coin Laundry (located at the corner of Hammond Avenue and Chamberlayne Avenue), walking north on Chamberlayne will walk over 1100 ft before reaching either an intersection or the pedestrian signal at Brookland Park Boulevard.

- Provide additional signalized crossing options for pedestrians on Chamberlayne Ave.
- Add high-visibility crosswalks across all side streets and driveways along and across Chamberlayne Ave.
- Provide leading pedestrian intervals and more time for pedestrians to cross Chamberlayne Ave.
- Add pedestrian refuge islands at all pedestrian crossings on Chamberlayne Ave.

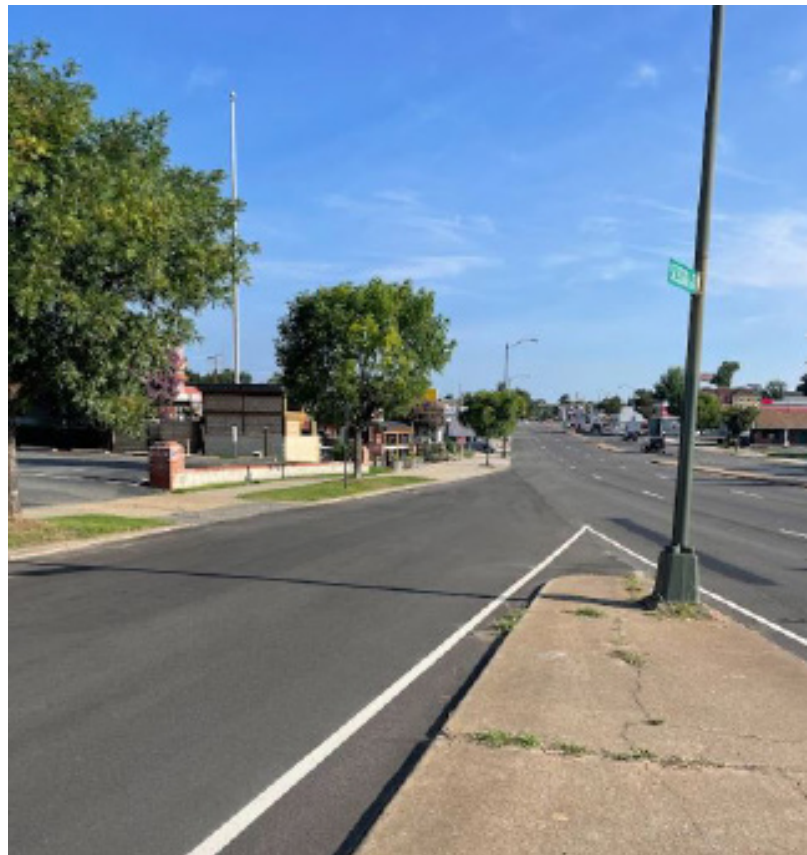
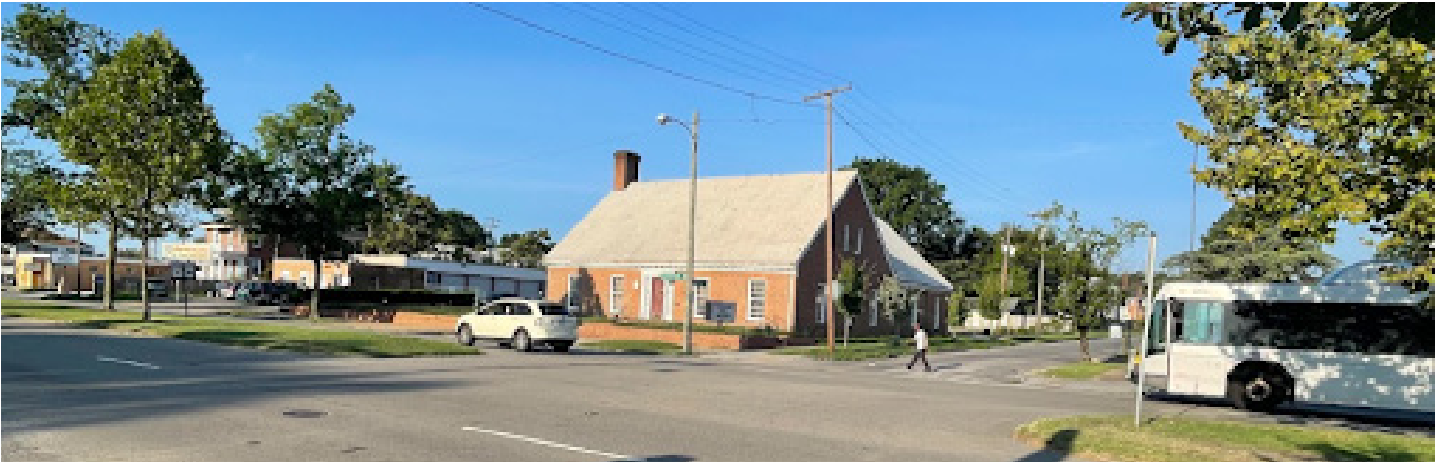
The design of some intersections makes it more dangerous for pedestrians to cross. At Chamberlayne Ave and Sledd St there is no clear way for people to cross and there is an ADA ramp on one side but no ramp on the other side, making it impossible for wheelchair bound pedestrians to cross safely. The slip-turn right lane also encourages drivers to speed through this intersection.

These lanes allow drivers to make fast right turns and drivers often overlook yield signs and pedestrians. Three slip-turns exist for right turns along the focus corridor, at N. Lombardy Street, Tazewell Street, and Mitchell Street.

The Tazewell and Mitchell Street slip-lanes are unmarked. Unmarked Intersections are common along the study corridor.

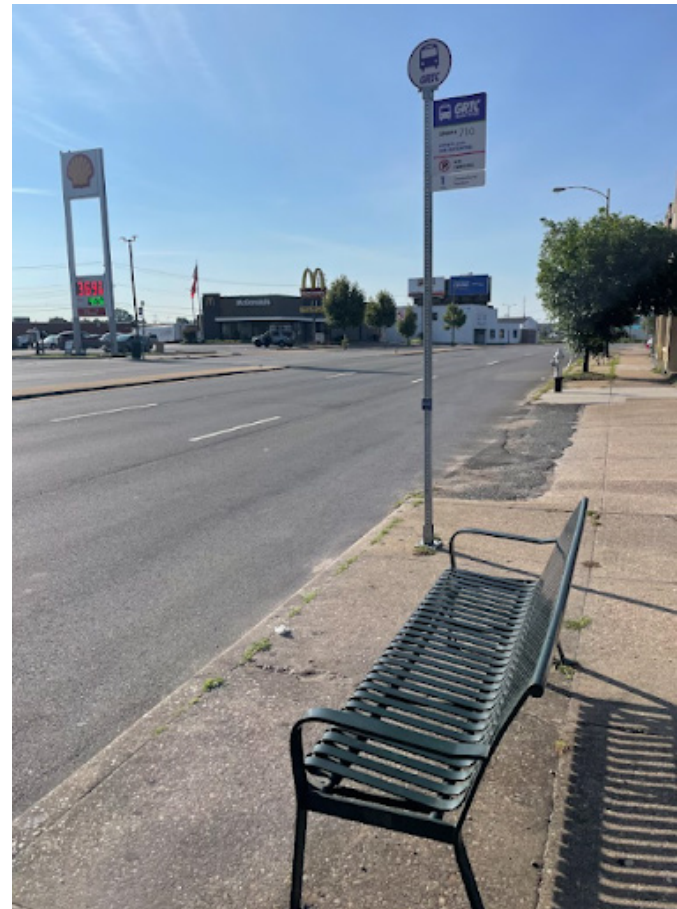
Of the fifteen (15) bus stops in the study area, only four have a bench. All bench stops are located on the west side of the street at Hammond Ave, Edgehill Rd, Mitchell St, and School St.

None of the bus stops include shelter from rain and sun for commuters. Of the fifteen (15) bus stops, fewer than five (5) provide trash receptacles for commuters. Stops without a trash receptacle had more litter and debris surrounding the bus stop wait area.

- Install more pedestrian-scale infrastructure along Chamberlayne Ave, including:
- Street trees for shade
- Benches
- Shelters, especially at bus stops
- Pedestrian-scale lighting
- Bike parking
- Roads running parallel to Chamberlayne Avenue and interconnected roads such as Lombardy Avenue have be reconstructed to include cycling infrastructure (i.e., protected lanes and road markings)
